Phase II: EVALUATION OF COOL PAVEMENT SURFACE TREATMENTS USING FRICTION, TEXTURE AND ADHESION PROPERTIES

**PREPARED FOR:
City of San Antonio**

**REPORT DATE
24 January 2025**

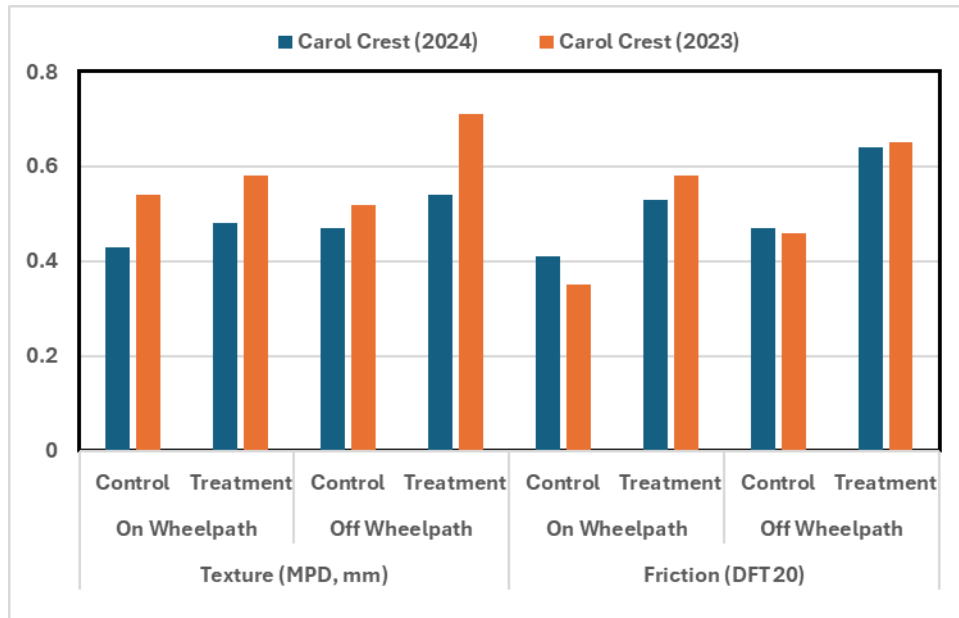
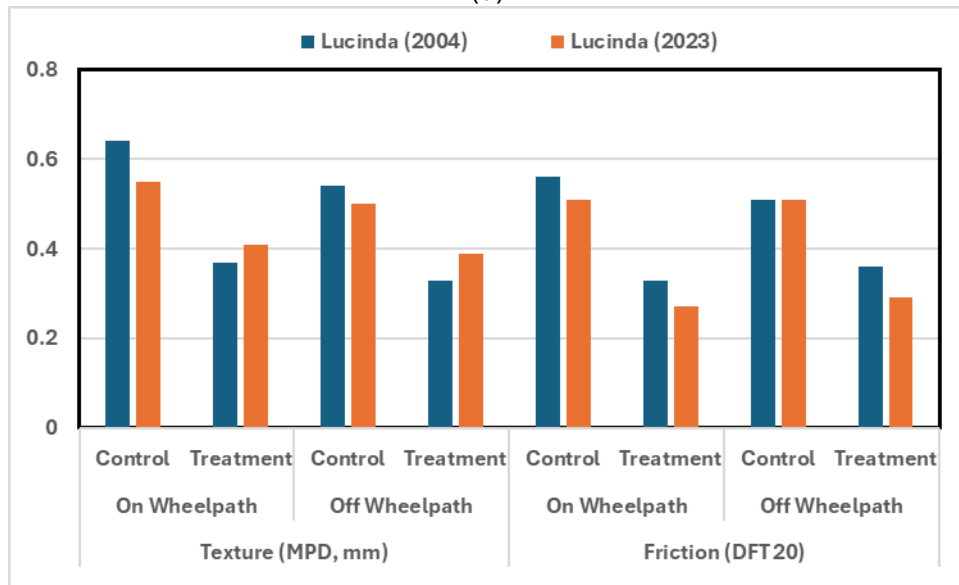
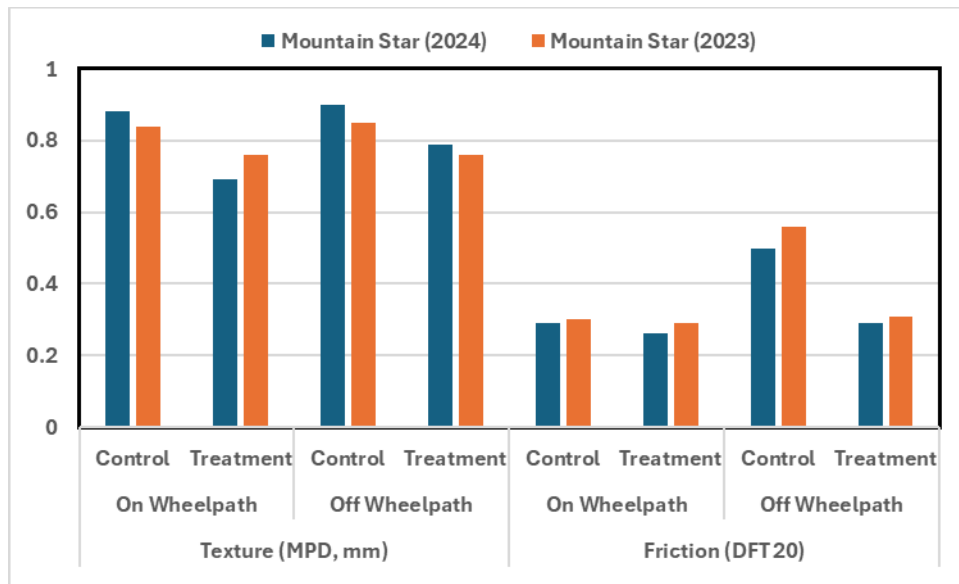
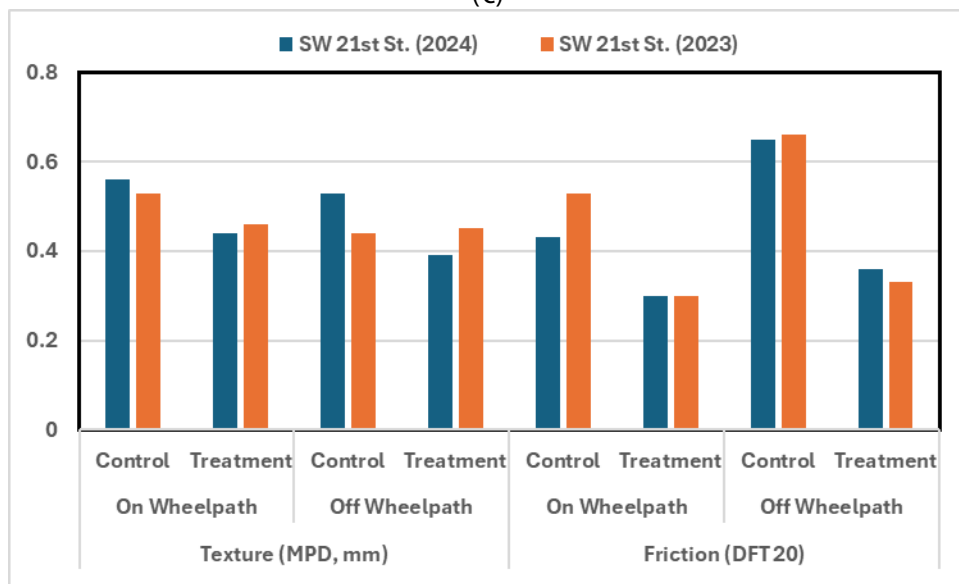
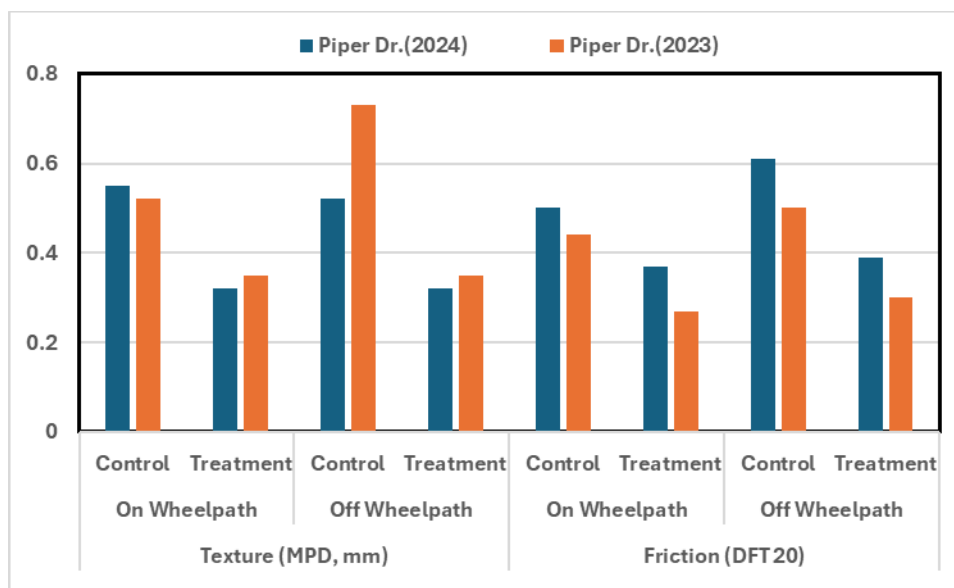
Figure 18. Summary of texture and friction measurements for all projects in 2023 and 2024.

Figures 18 (a-e) present the texture and friction measurements of Tables 22 and 23 for the five sites. In general, there is no specific pattern that supports whether either texture or friction increases or decreases due to traffic and environmental effect. As suggested by literature, dependent on asphalt pavement materials characteristics (e.g., aggregate type, binder source and grade, air voids, etc.) they tend to affect the evolution of texture and friction over time (Xiao et al. 2023). Generally, the applied treatment to certain extent can help with restoring texture and friction on deteriorated surface to meet specification guidelines but not necessarily maintain them over a period of time.

As can be shown, the applied treatments at four sites with SealMaster and GuardTop tend to reduce the surface texture by 30% in 2024 and by 20% in 2023 as compared to control pavement. However, on the contrary, treated sections tend to decrease the friction by 32% in 2024 and 39% in 2023 as compared to control pavement. The GAF treated site, on the contrary, showed increase in texture by 13% in 2024 and 22% in 2023 and friction by 33% in 2024 and 54% in 2023. As expected, increasing texture is generally associated with increasing friction and vice versa. The consistency for this trend in all sites after >500 days of performance suggests that the treatment continues to maintain and preserve the surface characteristics under traffic and environmental effect changes. There are two factors that affect treatment performance; environmental effect and traffic. The following is a discussion on the effect of traffic and environmental effect on the texture and friction of cool pavement treatment considering their performance since installation.

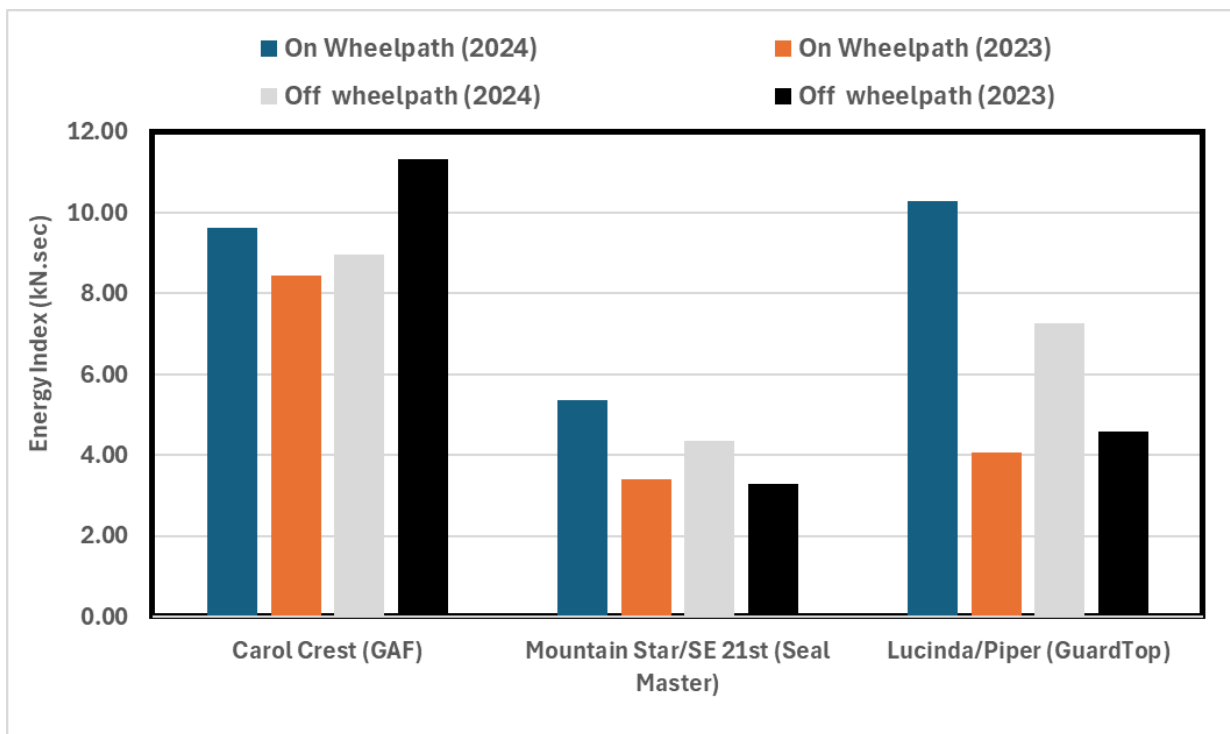
Figure 19. Evolution of adhesion strength over time.

Another consideration is the aging of the coating materials over time that also contributed to increasing adhesion. This is supported by the evolution of adhesion over time as shown in Figure 19. The bonding strength systematically increases by various degrees among the cool pavement products after nearly a year from the last testing phase in 2023. The only exception was the GAF at the off wheelpath area.

It is noted to mention that adhesion testing was limited to a single point at each of the sites in Table 24 due to the limited time provided by traffic control to conduct multiple testing points. Therefore, further testing is highly suggested to account for testing variabilities within the site.
